# PRODUCT DESCRIPTION & TECHNICAL DATA SHEET

SKU: 01150086

## MB Vito, tailgate, 2014/06 - | Warning marking set

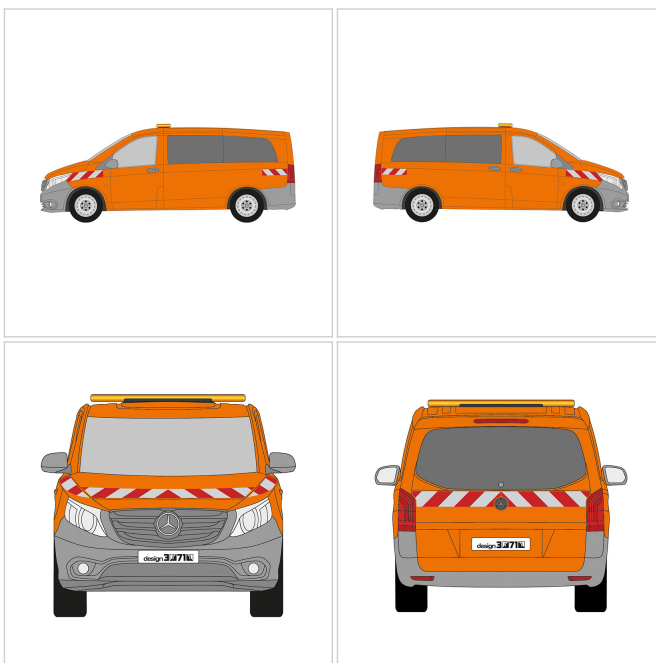
Manufacturer: Mercedes-Benz  
Type: Vito, W447  
Year of construction: 2014/06 -  
Rear: tailgate  
Scope of parts: 10 parts  
Main category: warning marking kits  
Model: Vito

Ready-made, tension-free elements for easy self-assembly in design112 quality with rounded corners and no sharp edges on the surfaces. For minimal contact area and maximum service life.

**Red/white:** Warning marking design30710 red/white microprismatic – Oralite 5921M – warning marking red/white in accordance with DIN 30710 for fixed structures – in accordance with RA 2

The starting point of the striped pattern may differ slightly from the illustrations. However, this has no relevance for approval and/or safety effectiveness.
